# Manhole Inspection Summary

Manhole # S07EE2006MH

**Location** Address: **2501 STEELE RD** Cross Street: **GREENSPRING AVE**

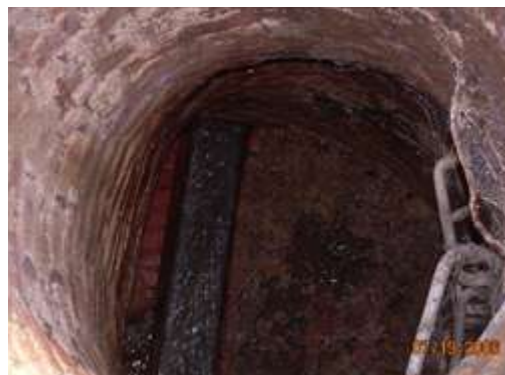
Top View

Corbel and Barrel root intrusion.  
Adjustment, Corbel, and Barrel infiltration.  
Evidence of surcharge - Bench debris.

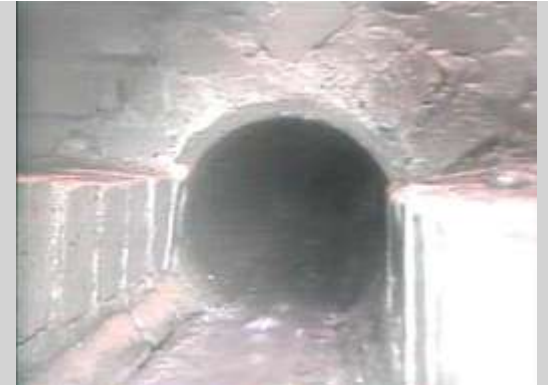
### 10 in. Circular Gravity Sewer Pipe Out @ 12 O'Clock

Infiltration: **Evidence** Pipe Seal Cond: **Unknown**

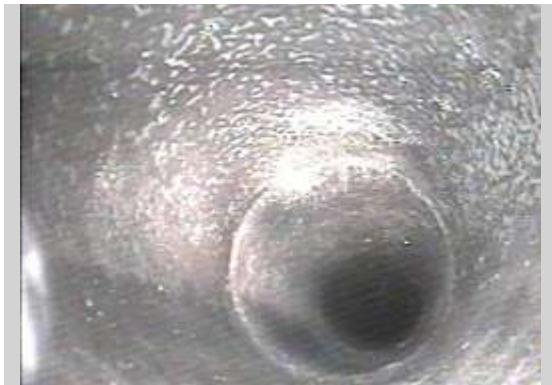
### 12 in. Circular Gravity Sewer Pipe In @ 2 O'Clock

Extra pics of possible open overflow

Infiltration: **Evidence** Pipe Seal Cond: **Roots**

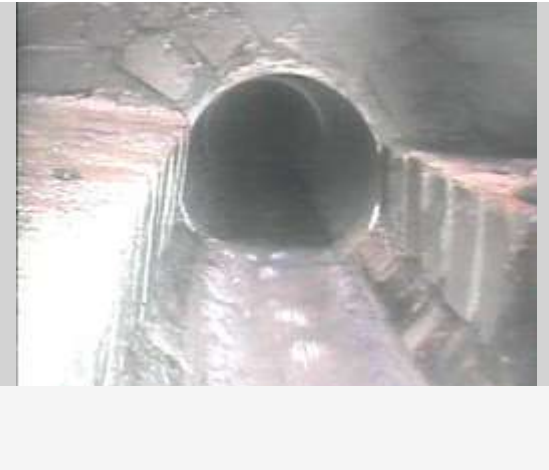
Pipe In @ 6 O'Clock

Infiltration: **Evidence** Pipe Seal Cond: **Unknown**

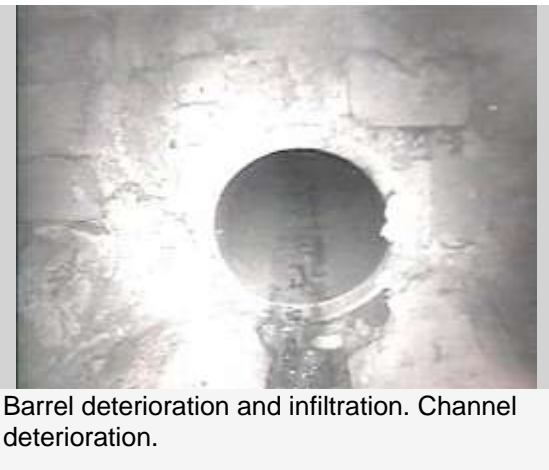
Pipe In @ 9 O'Clock

Comments **The I9 pipe picutre shows Barrel deterioration and infiltration.**

Barrel deterioration and infiltration. Channel deterioration.

Infiltration: **Evidence** Pipe Seal Cond: **Unknown**
